Home Inspection Report

906 Meadow Ridge Drive, Clarinda , IA 51632

Thursday January 21, 2021

House To Home Carpentry And Inspections Inc.
2936 260th Street
Clarinda, IA 51632
7125420253
jasonrenander@yahoo.com

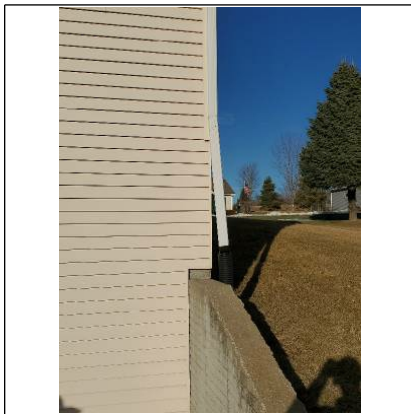
Comments Downspout is loose on the southeast corner.

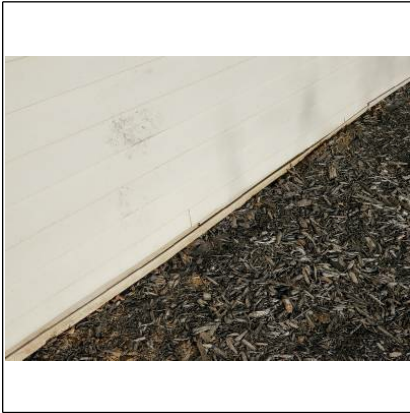
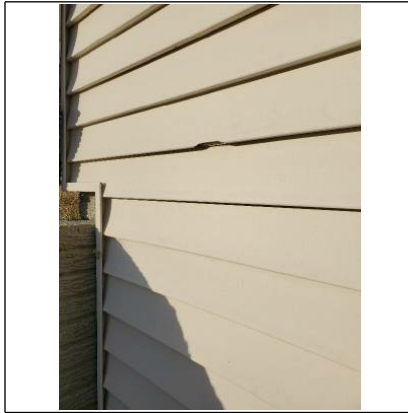
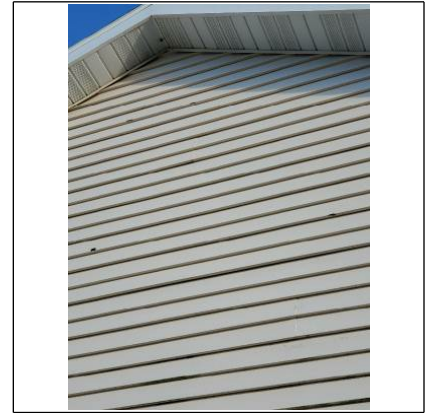
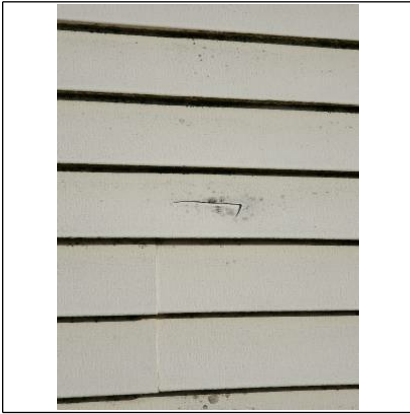
Siding is loose all along the bottom on the south side.

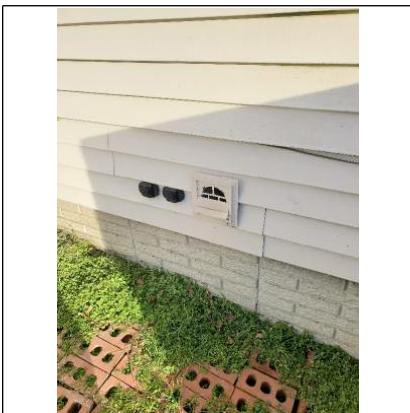
Comments Luffers are missing on the vent next to the AC.

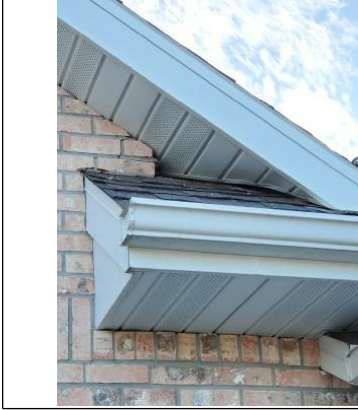
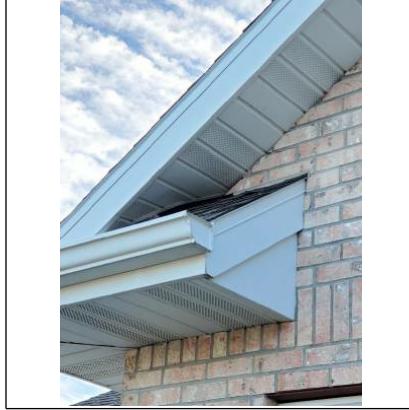
Comments Soffit is bent where it meets the roof on the front of the house and garage. Could possibly allow bats in and us allowing birds in.

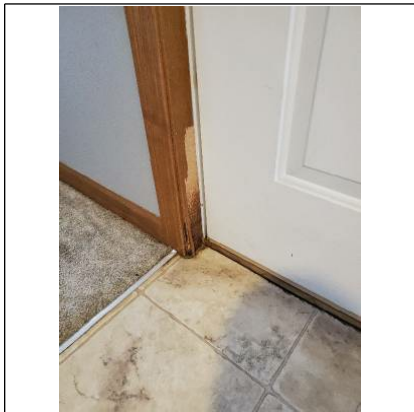
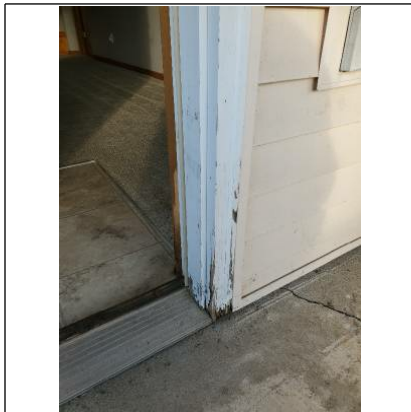
Comments Basement door trim needs painted on the exterior and the jamb has moisture damage at the bottom on the interior.

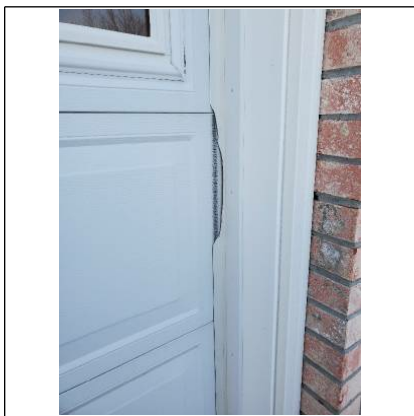
Comments Weather stripping is damaged on the west garage door.

Garage doors should have a strut installed along the top by where the opener attaches.

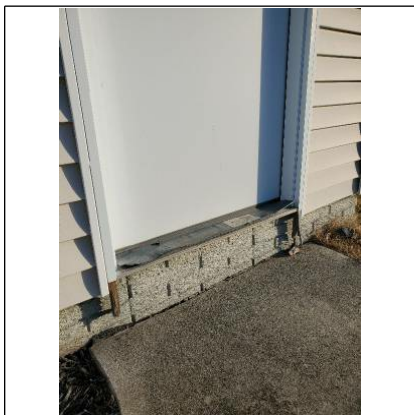
Comments Wood is coming out of the aluminum door trim on the exterior.

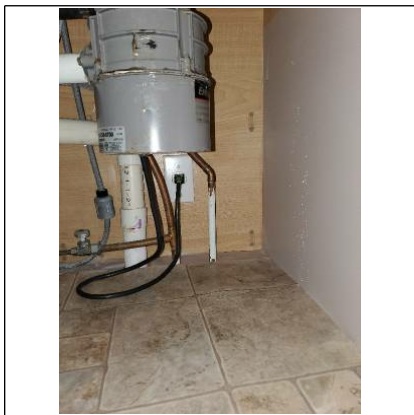
Comments Right side of the kitchen sink drain leaks from around the garbage disposal into the cabinet.

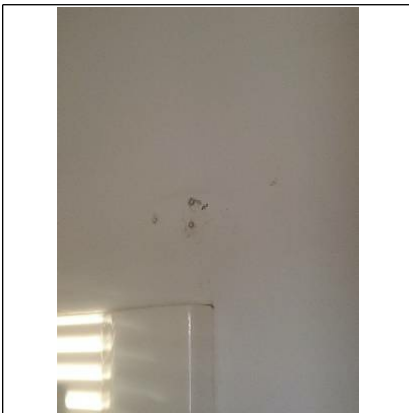
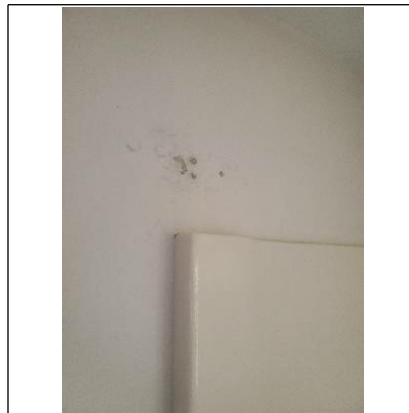
- Open ground/Reverse polarity** Yes No Potential Safety Hazard
- Heat source present** Yes No
- Exhaust fan** Yes No Operable: Yes No Noisy
- Comments** Faucet is loose and does not fully switch from the tub to the shower.

- There is some paint missing where the shower rod used to be.
- Caulk along the backsplash.

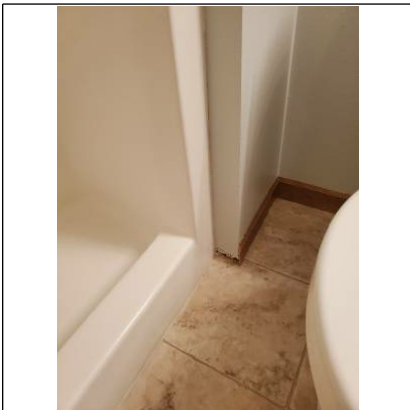
- Open ground/Reverse polarity** Yes No Potential Safety Hazard
- Heat source present** Yes No
- Exhaust fan** Yes No Operable: Yes No Noisy
- Comments** There is a piece of trim missing next to the shower.
Caulk along the backsplash.

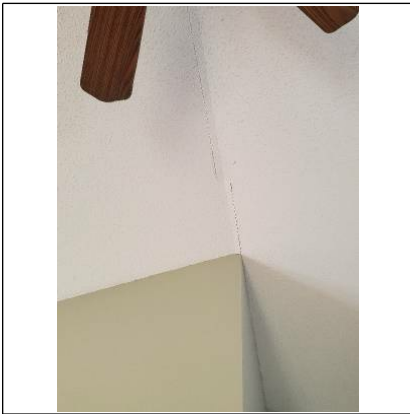
Comments There are cracks in the wall and ceiling of the living room.

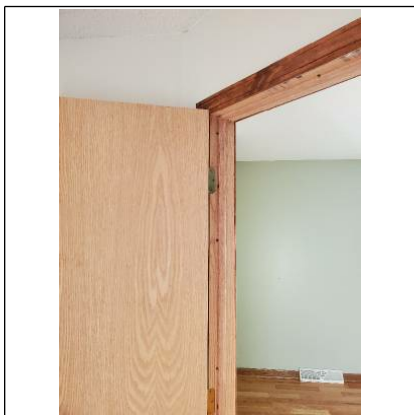
Comments Door is not stained.

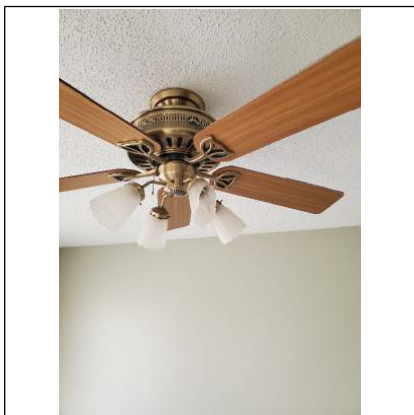
Comments Globe is broken on the ceiling fan.
