Hi Bret,
I would appreciate if you could review your estimate.
I will enclose a few pictures for your review.

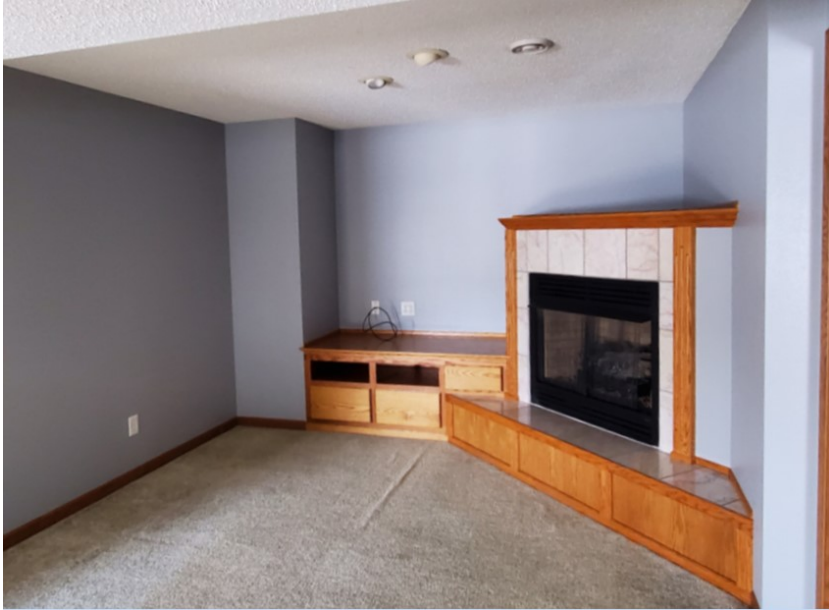
The above picture represents prior to damage.

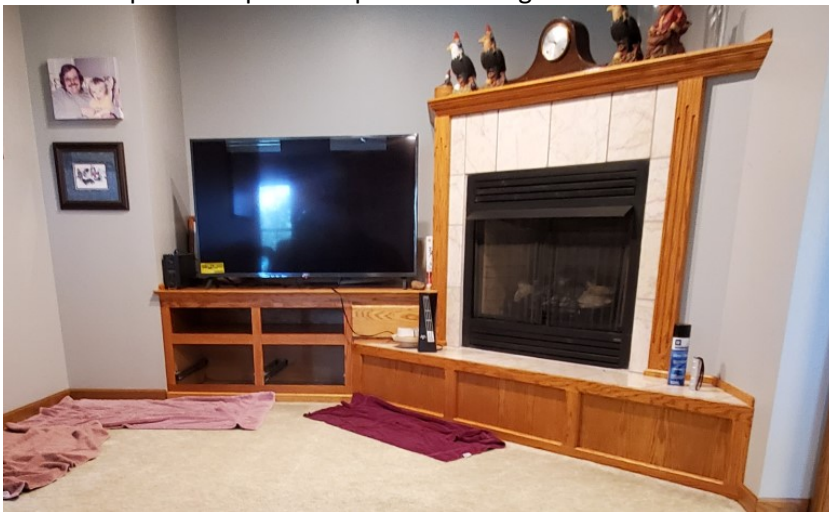
The above picture when water on carpet. 2 drawers are removed from stereo center.

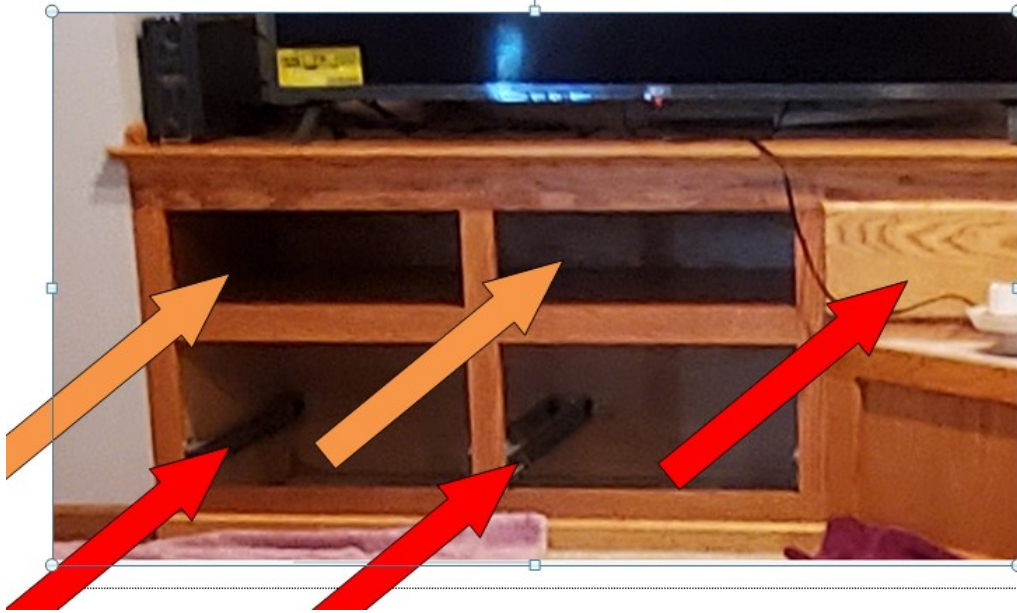
Above picture showing stereo cabinet 30Dx62Wx29H 3/4" PLY top and shelf with hardwood front, Back and sides were 5/8" oak PLY. Area behind the drawers was not stained. The area above the drawers is stained and sealed to a gloss. The whole unit was built and then put in place. The metal drawer slides are for 24 inch extra deep drawers. I don't believe there is enough material and labor in the estimate to cover replacing the stereo unit back to original. Please advise.

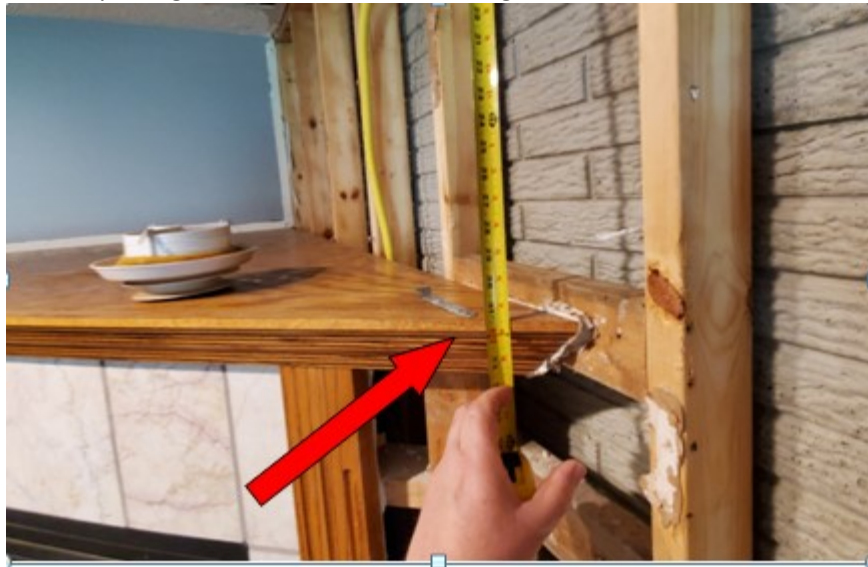
Sheetrock is not a big expense but it will take 80sf to cover the room.

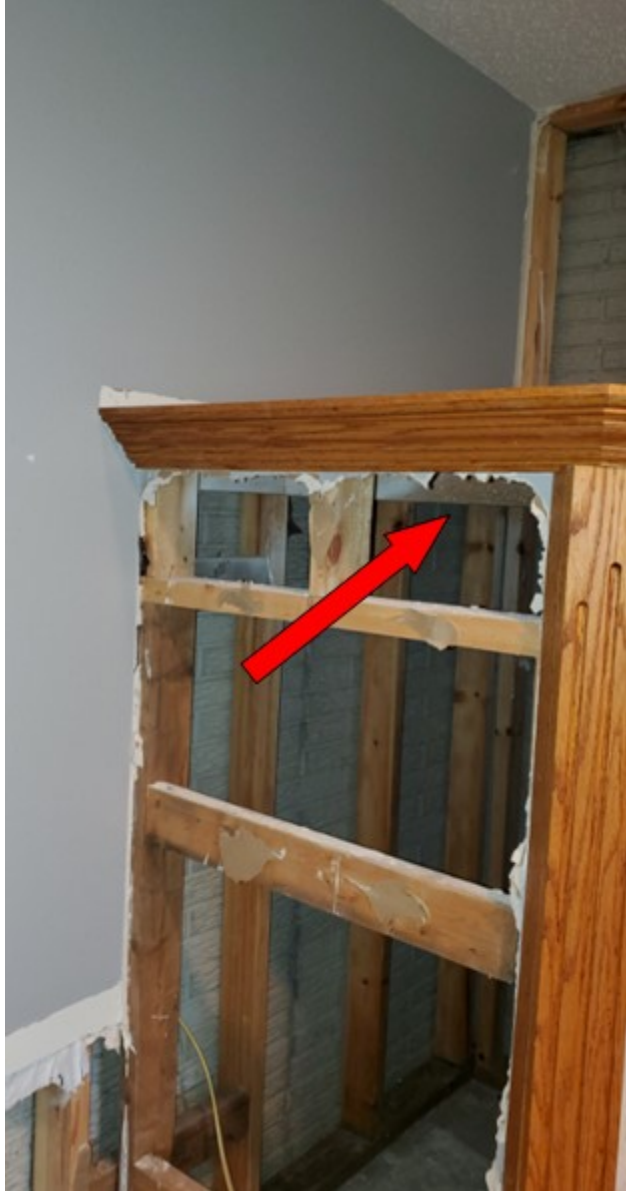
They pulled all the insulation from behind the fireplace. It will take about 116 feet of somekind of doublesided 3 1/2 insulation. JM label on the insulation. (It has a poly film on interior wall side and another film against the concrete) Service Master pulled the insulation from behind the fireplace including insulation in the wall cavity behind the sheetrock which will need 20sf of sheetrock to remove and reinsulate.

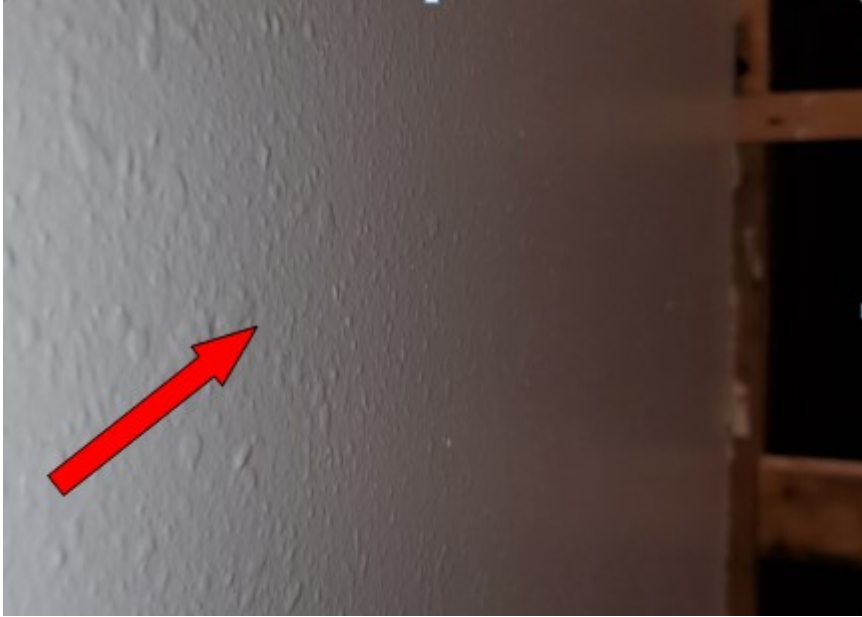
The wall texture is a medium splatter. I do not see a line item for wall texture.

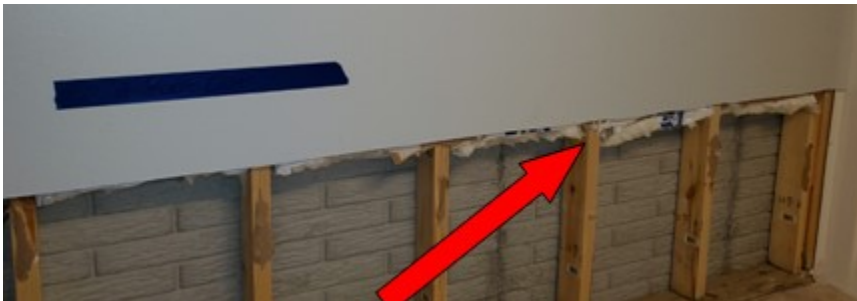
Insulation showing. I don't see a line item for insulation. Please advise.

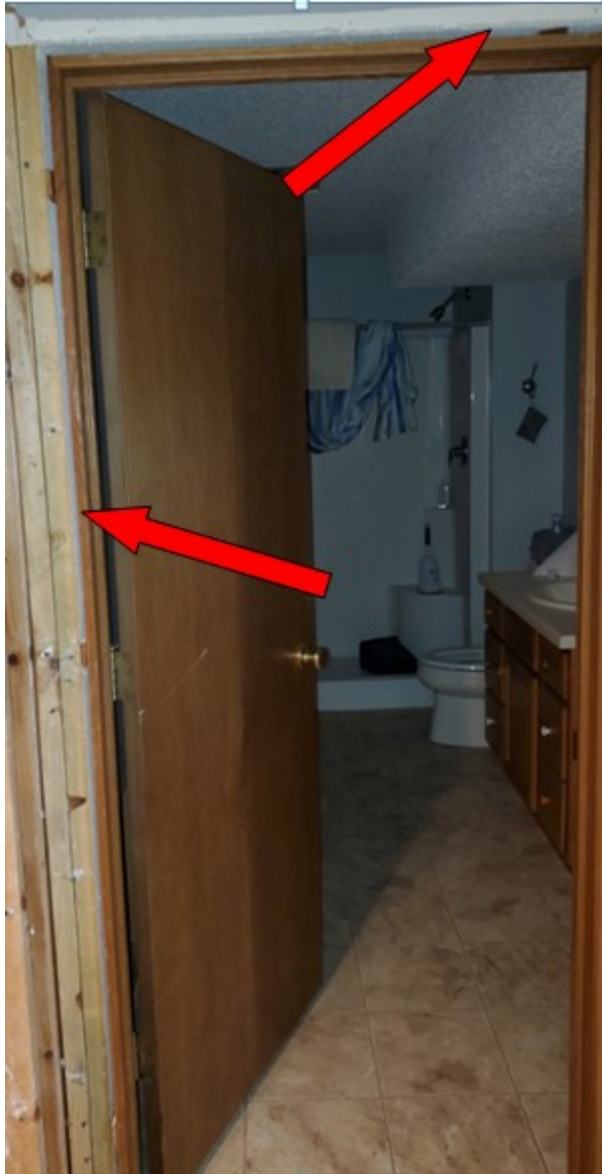
Service Master threw out the door trim and I don't see a line item for to replace. Please advise.
